Experimental Modeling of Pile-Leg Interaction in Jacket Type Offshore Platforms Cyclic Inelastic Behavior

Abstract: Offshore platforms in seismically active areas should be designed to survive in the event of severe ground excitations with no global structural failure. The annulus between the pile and leg in jacket-type offshore platforms can be filled with cement grout as a means of reducing horizontal deflections, inhibiting corrosion and preventing local damages. This paper discusses an experimental approach which can be used to demonstrate the effect of grouting on enhanced structural performance of jackets. In this regard, the lateral load bearing behavior of grouted and un-grouted jackets are investigated experimentally with special attention to effect of grout on pile-leg interaction. Results are presented on the cyclic inelastic behavior of two scaled frame models of a representative platform which was recently installed in the Persian Gulf. The objective of this effort was to improve the understanding of the behavior of jackets subjected to lateral motions and specially the effects of exact real pile-leg interaction. It should be noted that this paper addresses the exact

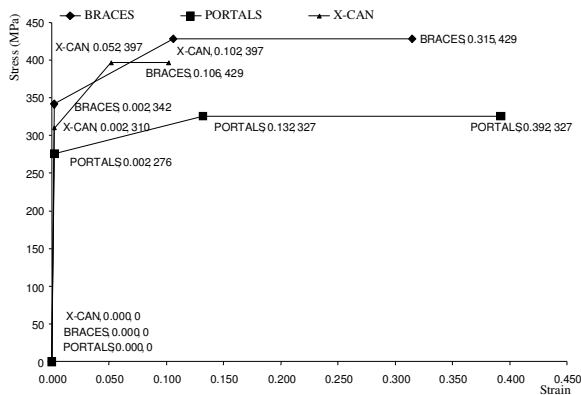
Fig. 3: Pipes material stress-strain curves, tensile test Results

Steel material behavior: Figure 3 and Table 1, show stress strain behavior of the pipes used for the specimen frames. Totally 8 samples were tested (4 for braces and 4 for portals). Two samples were tested for each size of used pipes.

X-bracing joint-can behavior: In this test, the behavior of braces was not focused on, but the portal behavior (both while working with braces and while working individually in bending) and the effect of grout on overall behavior were to be highlighted, therefore joint cans intentionally were not fabricated and the brittle failure (tearing) has occurred because of the Heat Affected Zone area which was developed while 2mm thickness pipes were being welded to each other. However the stress-strain curve of the can was derived by fabricating similar X connections and testing two specimens. The worst of resulted stress-strain curves is presented in Fig. 3 and Table 1.

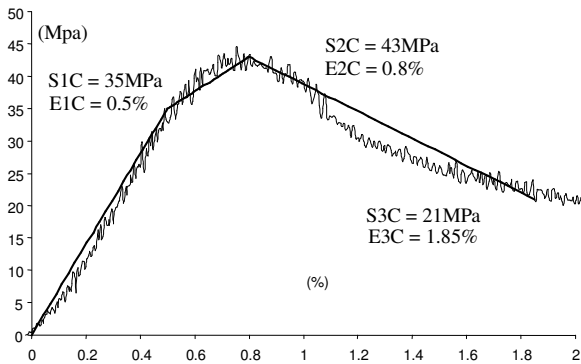
Fig. 4: Average resulted stress-strain curve of 4 grout samples and adjusted curve in drain software

Grouting material behavior: Some sample cubes (5×5×5 Cm³) of grout were tested under compression^[10]. The grout was made of seawater and cement type II (with Water/Cement weight ratio of 39% and 1.98 t/m³ density). Three of the cubes were cured in the wet normal open condition, while other three in the entrapped close condition to simulate the entrapped gap space between the pile and leg where no air circulation would exist. The samples were tested in the MTS machine after 28days. Two of incomplete cured and two of normal cured samples were tested. In real condition, the grout is neither completely entrapped, nor normally can be cured, therefore an average of the tests and the equivalent linear curve are plotted in Fig. 4.

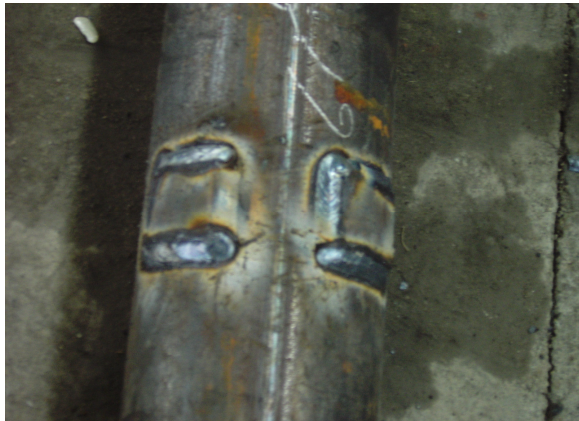
Fig. 5: Assemblage of shim plates on piles at mid-horizontal brace elevation

The welded shim plates on the piles are shown in Fig. 5. After the construction of separate items (Jackets, piles, shim plates, base plates and deck box), they were assembled to each other for both the frames. The connections of top and bottom of piles are shown in Fig. 6 and 8. After the completion of the frames, one was grouted in the gap between pile and leg using exactly the material and mix ratio mentioned above,

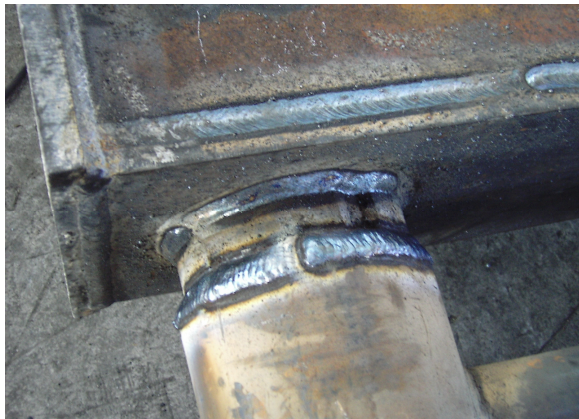
Fig. 6: Leg-pile connection joint, full-penetration weld of deck on top of piles

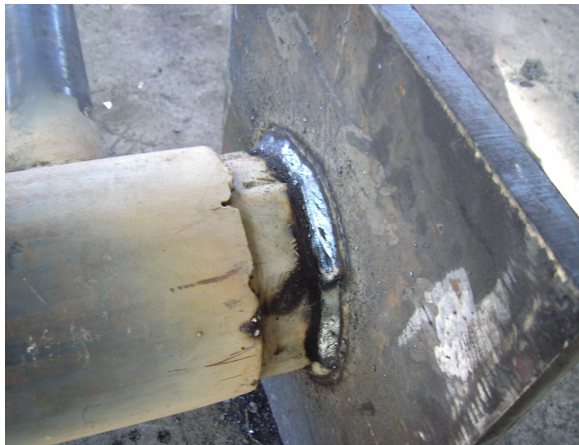
Fig. 7: Full-penetration weld of piles on base-plates, no weld between pile and leg

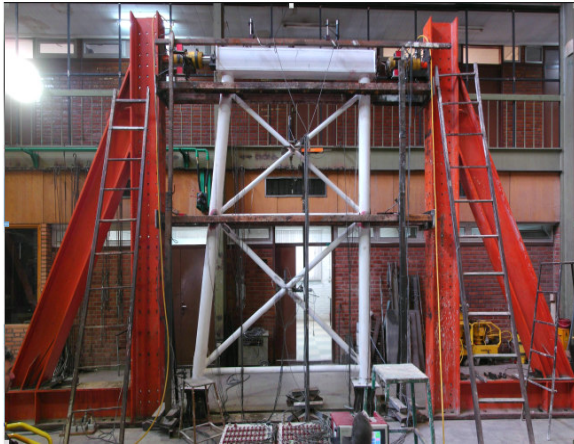
Fig. 12: General view of experimental setup

Figure 12 and 13 show the experimental setup including the pin support, hydraulic jacks, jacks support frames, lateral constraints, LVDT's, strain gages and general test layout.

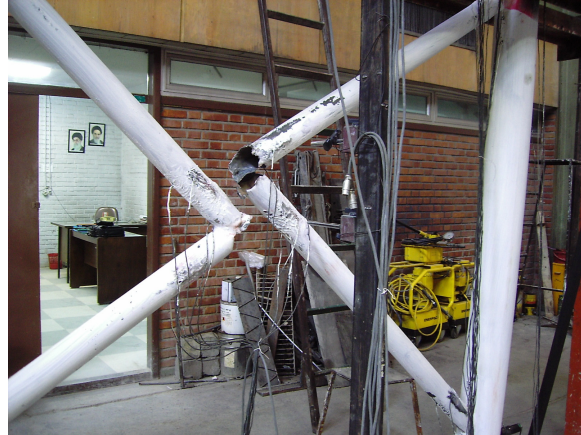
Fig. 15: Disconnection of x braces in later cycles

Both grouted and ungrouted frames were tested as detailed in previous section exactly in the same conditions. Summary of events and failure mechanism that happened during the tests are shown in Fig. 14. In the absence of joint cans in X braces, tearing failure occurred in the joints of lower and upper panels of both frames. In this test, as explained before, the behavior of braces (which was investigated many times before) were not focused on, but the portal behavior and the effect of grout on overall behavior was to be highlighted, therefore joint cans were not fabricated and a brittle failure has occurred, however the stress-strain curve of the can was derived (by fabricating similar separate X connections) and reported for further numerical efforts. Figure 15 and 16 presents photos showing the failure mechanism that happened during both the tests. In Fig. 16, a picture of the deformed shape of frames in the last cycle is shown.

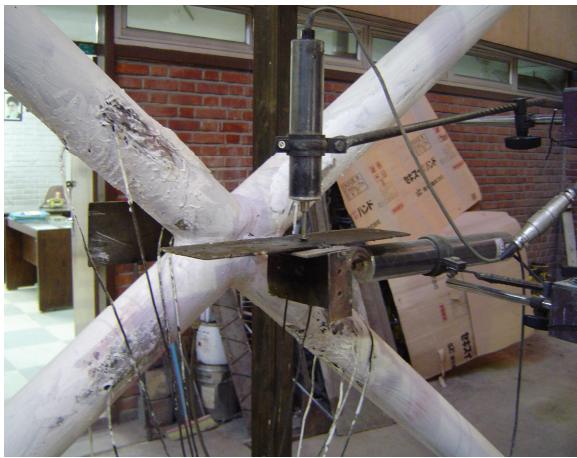
Fig. 13: LVDTs No. 17-19, strain gages 52-59, 68-71

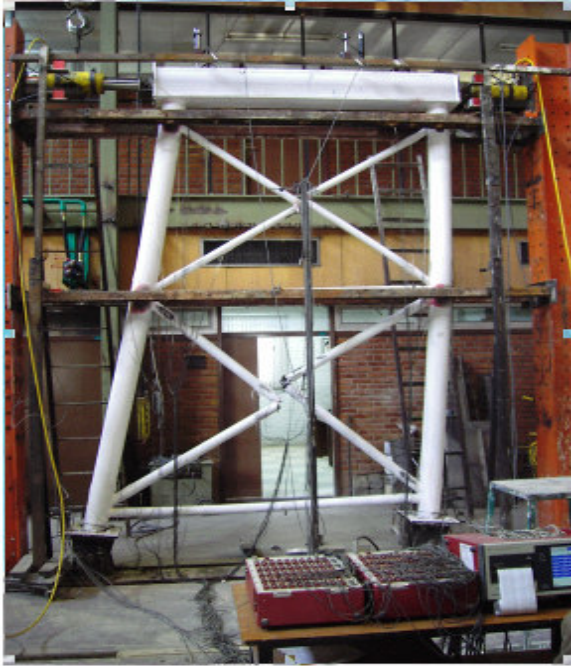
Fig. 16: Platform typical deformed shape (cy. 30, $\Delta = -20\text{cm}$), braces all disconnected

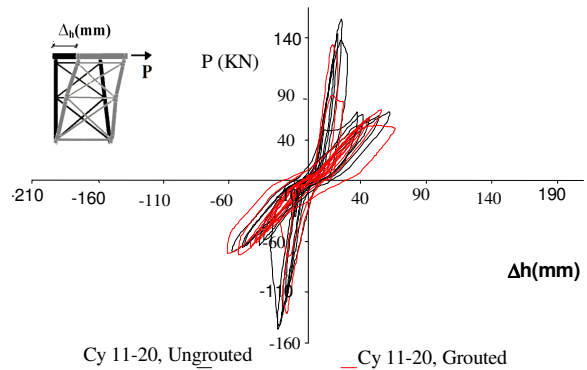
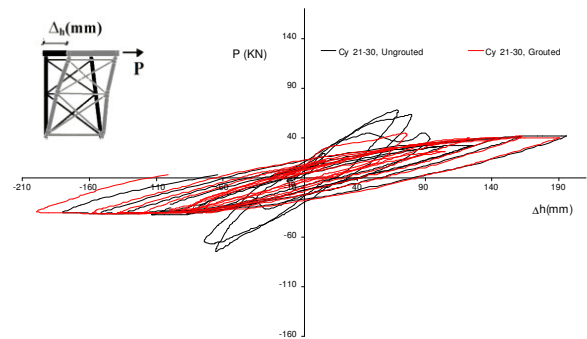
Fig. 17: Frame load vs. deck displacement (cy 1-30)

Fig. 18: Frame load vs. deck displacement (cy 1-10)

Fig. 19: Frame load vs. deck displacement (cy 11-20)

Fig. 20: Frame Load vs. Deck Displacement (Cy 21-30)

Overall behavior of test frames: The variation of deck load vs. total deck displacement is presented in Table 3, 4 and Fig. 17-20 for different range of cycles as the hysteretic curves of overall frames behavior compared between grouted case and un-grouted.

There seems not to be a significant difference in hysteretic behaviors of the two cases, but generally it was seen that in grouted case, lateral stiffness of portal elements (only while working in combination with the braces and not as a lone individual lateral system) and

as the lone individual lateral system (pure portal behavior), is quite the same in both the cases. This fact can be seen in last cycles of hysteretic behavior curves where all X bracings are cut and frame behaves as a pure portal system. This is due to the low effect of grout in the composite section while the section works in bending specially with low values of axial compression^[10]. However, while portal elements work

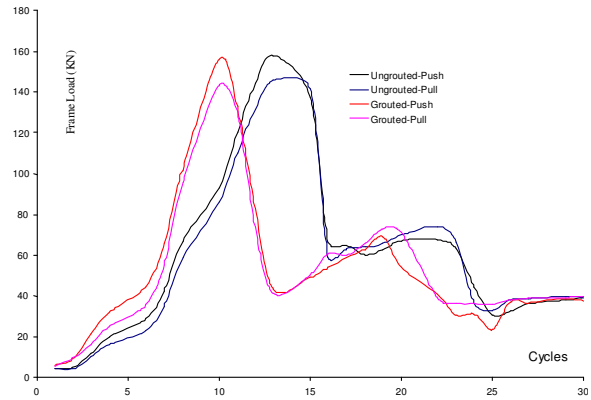
Fig. 21: Frame maximum loads at cycle displacements

The maximum lateral loads per cycles are plotted in Fig. 21. The envelopes of hysteretic curves for both cases are compared in Fig. 22. The energy dissipation per cycle and cumulative dissipation curve are plotted in Fig. 23 and 24. It was found that cumulative energy dissipation curve of grouted specimen is above the un-grouted specimen, but only before tearing happens. Therefore if joint cans had been modeled, tearing would

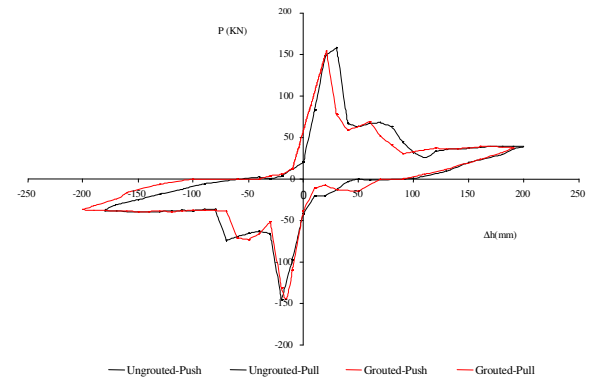
Fig. 22: Frame load vs. deck displacement response envelopes

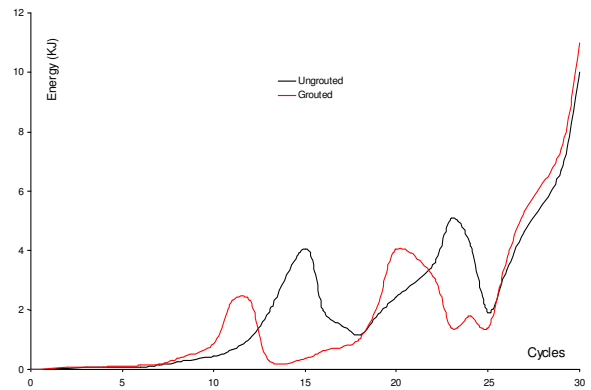
Fig. 23: Frame energy dissipation per cycle
